Summary of Water Quality Assessment Findings
Greywater Sampling Report 3
Auja and Marj al Ghazal
Sample Date: 2019-10-24
Written By: Natalie Brassill

On October 24, 2019 a team of scientists from the Arava Institute traveled to the West Bank to Auja and Marj al Ghazal, for the third time, to assess Grey Water Treatment Systems that have been installed on site at homes in the area to treat household greywater using a similar design to the Septic Tank Up Flow Gravel Treatment unit as shown below in Figure 2.1. (Greywater Use in the Middle East: Technical, Social, Economic and Policy Issues, Monther Hind design) This design was modified by Monther Hind to fit the needs of each on site location.

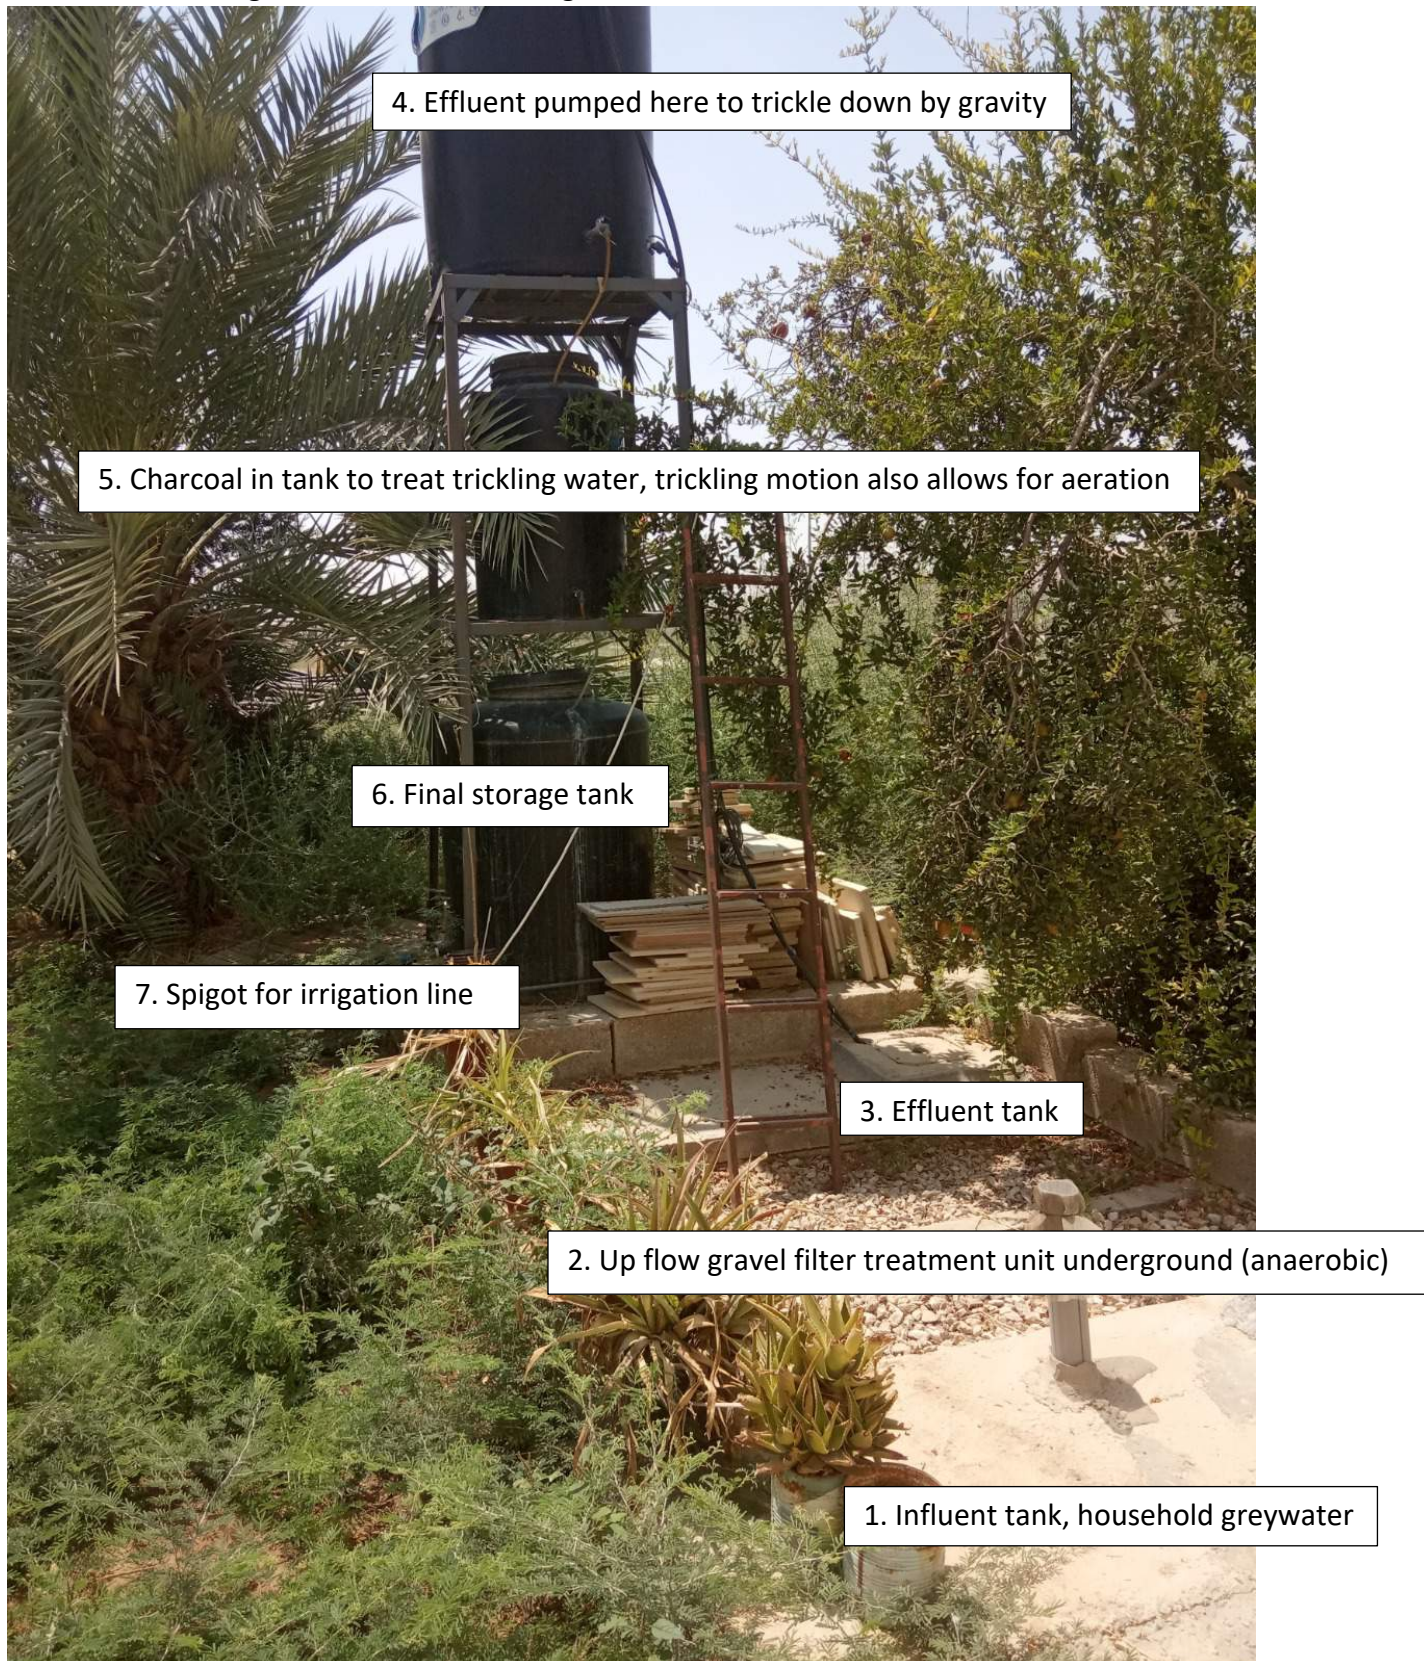
Photo 1 below was taken from the first homeowner, Khalid's Farm, and shows the tower in which the greywater is pumped to post Septic Tank Up Flow Gravel Treatment. The Septic Tank Up Flow Gravel Treatment is an anerobic treatment without oxygen and the tower is an aerobic treatment with oxygen and with charcoal. This is the design of the three systems that were sampled in the West Bank on October 24, 2019 by Natalie Brassill (University of Arizona, Water Microbiologist), Davis Blasini (Arizona State University, Plant Physiologist) and Tom Groenveld (Ben Gurion University, Biogeochemist). This team of scientists visited 5 different locations to collect water samples of influent and effluent greywater. Influent comes from homes located near the Septic Tank Up Flow Gravel Treatment and is greywater from either a single household or multiple houses holds. Greywater is sink and shower wash water that does not contain feces. Blackwater is toilet water and is sent to a septic tank and kept separate. Effluent is post treatment greywater from the Septic Tank Up Flow Gravel unit and aerobic charcoal tower unit. It is considered effluent after it goes through the Septic Tank Up Flow Gravel unit below ground and still effluent after it gets the additional treatment of charcoal and aeration.

Photo 1. Anerobic gravel treatment below ground and aerobic with charcoal above.

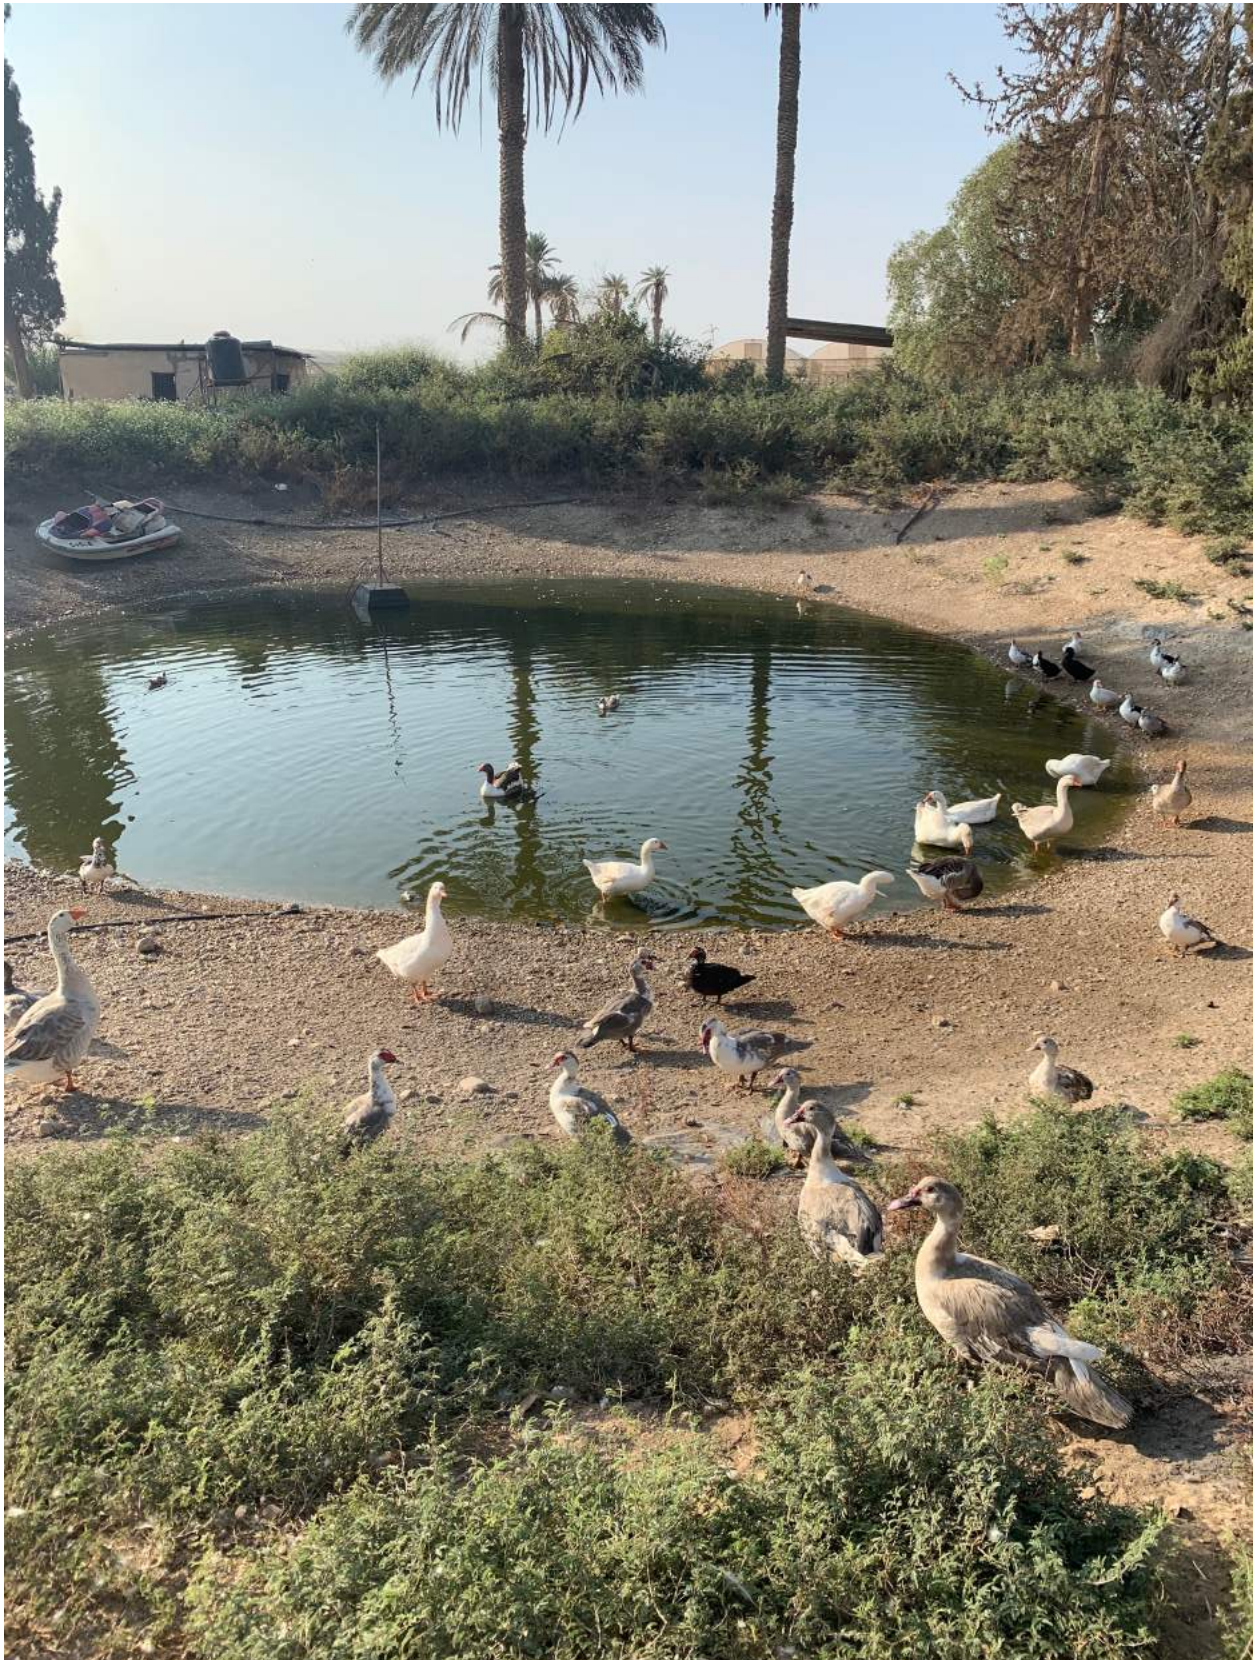
Photo 2. Khalid's Yard October 24, 2019

Khalid makes goat cheese, harvests honey, grows bananas, a few lemon trees, a few grape trees and many date palms trees. He uses this greywater to water his date palms and also his green house. All watering takes place using drip irrigation. He has grown cherry and table tomatoes and paprika in his green house. He is moving his greenhouse to accommodate a water desalination system for agricultural water that he is installing in December 2019 and will not be growing tomatoes until January 2020. Khalid gets his agricultural water from a well on his property that he shares with some surrounding farmers. Khalid is happy to have the Household Greywater Treatment System (GWTS) on his property because this allows him to not have to pump his septic system as often. Before the GWTS was installed Khalid would have to pump his septic system once every 2 months because he would have both grey and black water in the septic tank, and it would get filled to capacity quickly. Now that he has the GWTS and the greywater is now diverted to the treatment system and the water is used to irrigate trees he has less water going into his septic tank and now needs to have it pumped once every two years. The amount of treated greywater that is produced is only enough to water about 10 date palm trees according to Khalid and he says that this is about 10% of his total irrigation water portfolio. In 2018 Khalid grew paprika in his greenhouse with the treated greywater and made 700 NIS in profit. He also grew ½ ton of table tomatoes and make 3000 NIS in profit that same year. He tried to grow cherry tomatoes, but it was not successful, and he thinks this maybe related to the water quality for growing. Overall Khalid is happy to pump his septic less and have some additional water that is not so saline near his greenhouse. I did discuss with Khalid in detail how the water has very high levels of *E. coli* bacteria and is not good for public health if you do not use subsurface drip irrigation. He understands this and aware of cross contamination. He practices handwashing and does not let his crops touch the treated greywater.

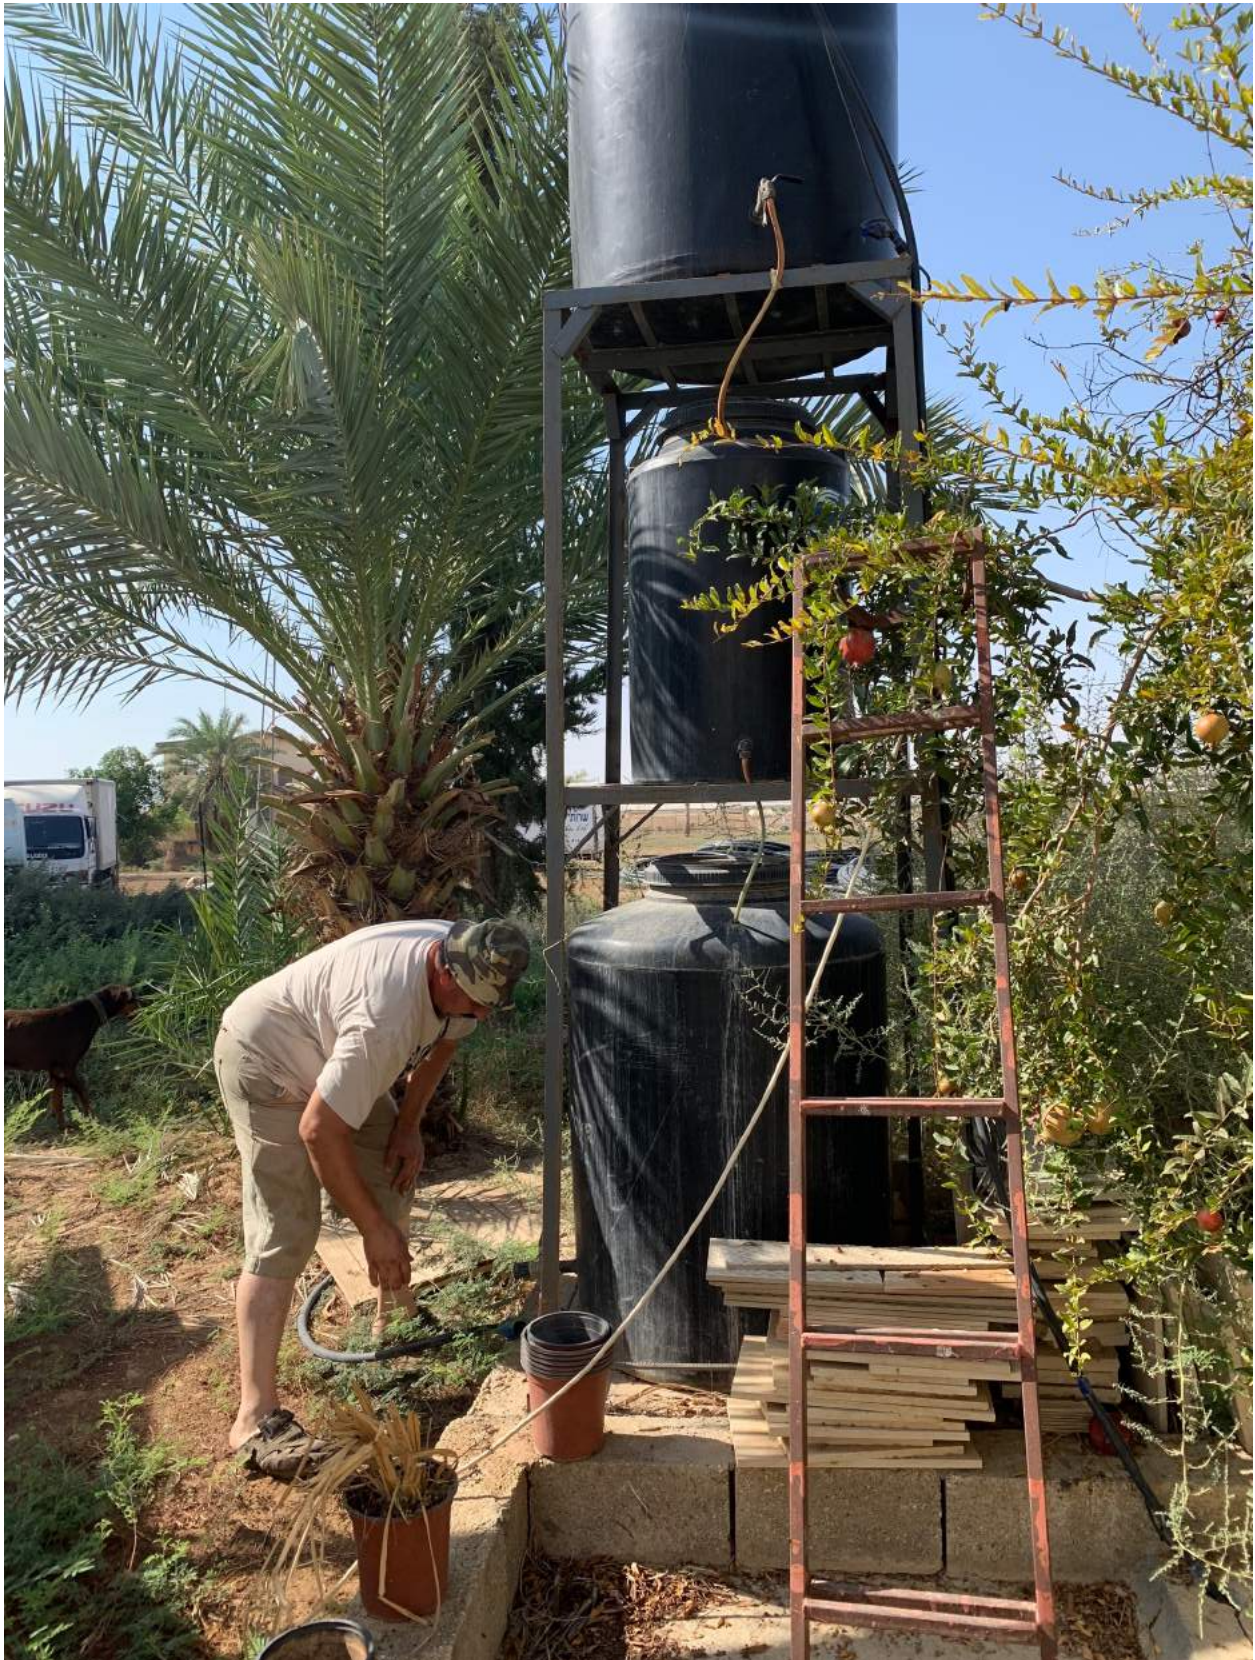
Photo 3. Khalid and his system aerobic charcoal tower on October 6, 2019

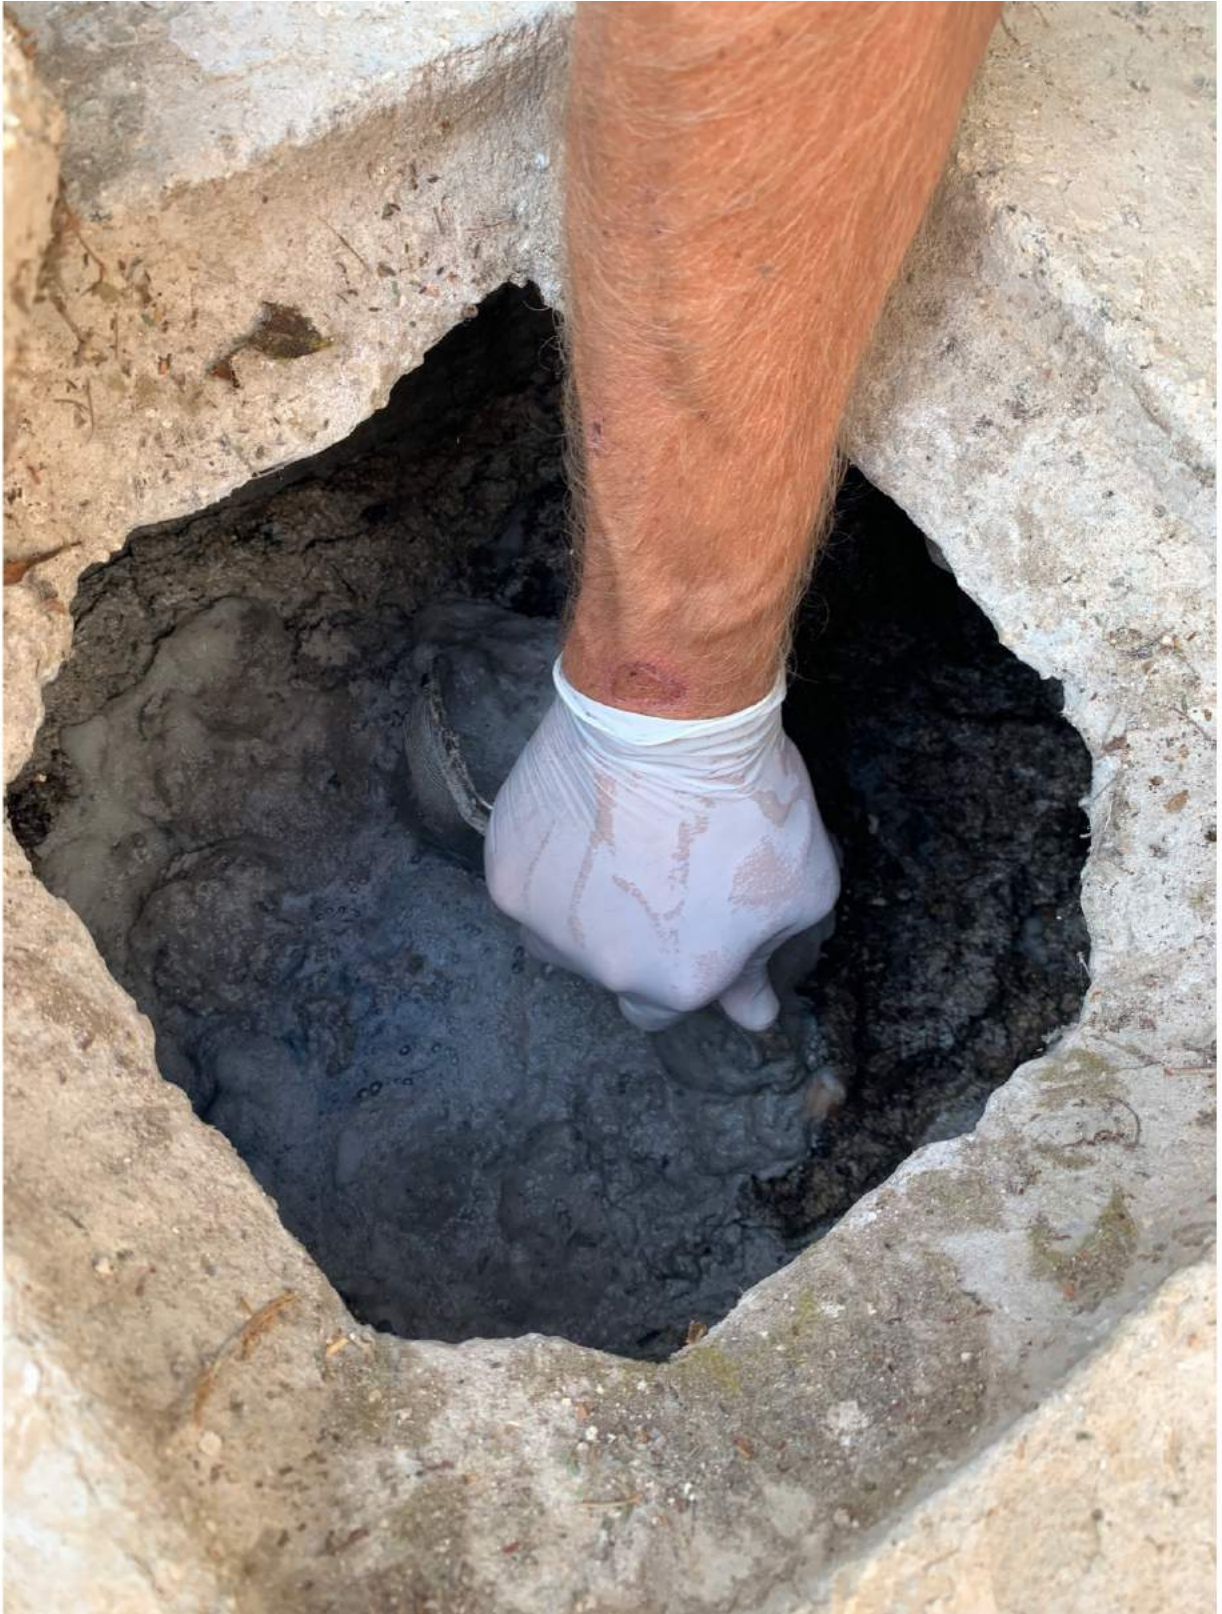
Khalid has a farm that has ducks, geese, goats, cats and dogs. In this last event we did not see a reduction in *E. coli* bacteria in his system like we saw in the first two events as seen above in Figure 3. He has not cleaned the system since 2019-09-21.

Photo 5. Sampling Khalid's Influent Tank with visible scum October 24, 2019

shown that *E. coli* treatment has gradually worsened since over time (9/23: 1500 MPN/100mL, 10/6: 4830 MPN/100mL, 10/24: >10,000 MPN/100mL). The system potentially needs to be cleaned again. It was last cleaned one month ago. The pH went from 6.28-7.95 becoming less acidic and more neutral which is good. EC is expected to be lower but during this assessment EC went up from 316 ppm to 398 ppm, but this is not a large increase. This was also observed in Report 2. DO increased from 1.08 to 3.85 when using the charcoal tower but actually decreased from 1.08 to 0.79 as measured from the underground effluent tank. The turbidity was significantly reduced from 1680 NTU to 27.73 NTU which is fantastic for drip irrigation to help limit clogging of lines. Positive results showing that the system is treating the water for turbidity. During this sample event Khalid's system did not reduce *E. coli* bacteria and it was found to be >10,000 MPN/100mL in the influent and effluent. This water is only safe to put on trees using subsurface drip at these bacteria readings. Overall at Khalid's Farm the household grey water is being treated and has reductions during this assessment. We also assessed his household municipal water that he receives through pipelines but does not drink. There were no *E. coli* bacteria found in the water but there was Total Coliforms found. This is a positive result to have no fecal indicator organisms but also shows that there could be dirt in the system or a leak of some kind. Total coliforms live in all soil. Drinking water should have zero bacteria period. Khalid's water did not have *E. coli* but did have Total coliforms, so it is good that he does not drink this water and just uses it for showers and boiling. It is similar to river water with these readings. The Total Coliform results show 48.3 MPN/100mL and that is low. This water should be evaluated more to draw accurate conclusions.

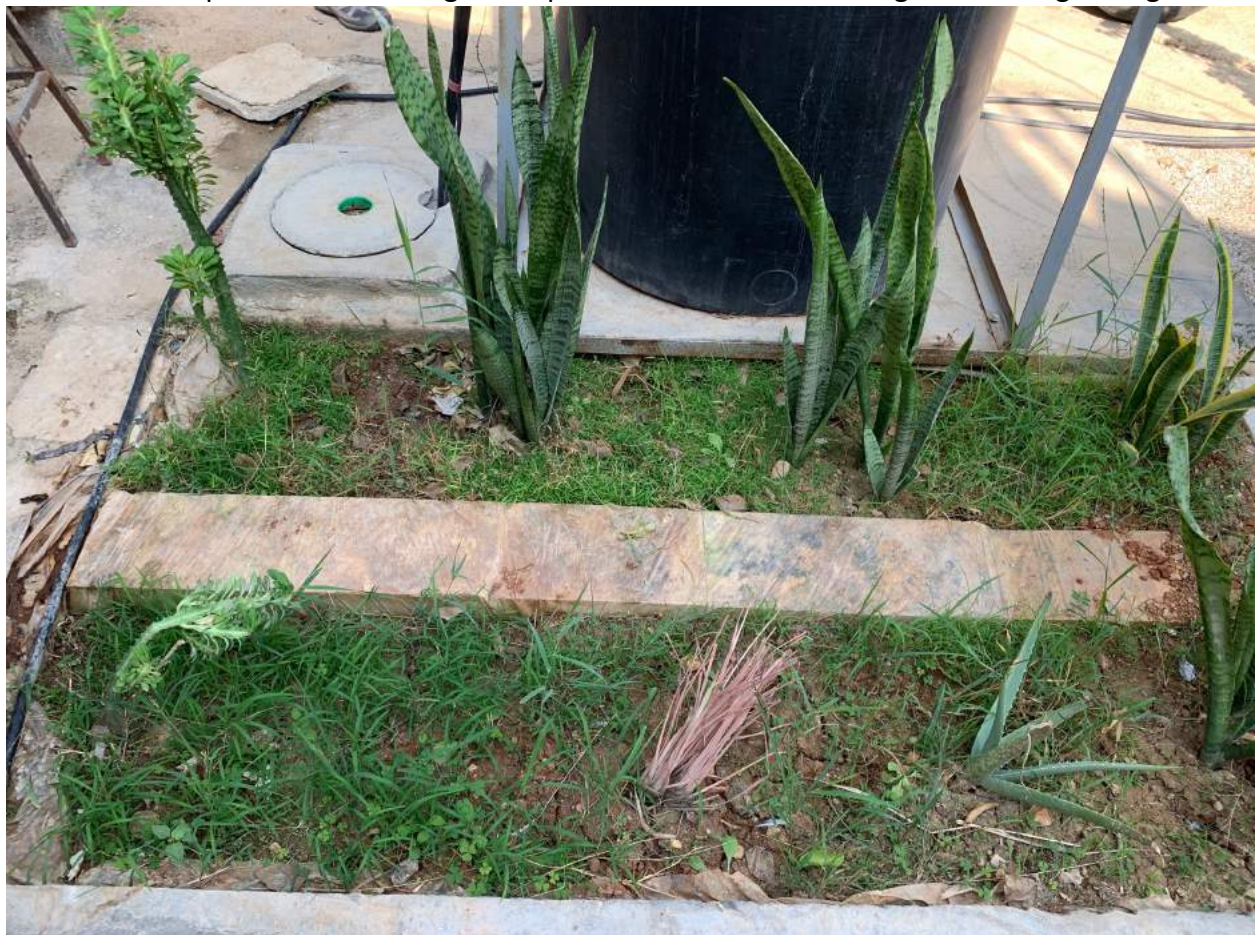
Photo 7. The top of Jihad's GWTS gravel upflow tanks with beautiful green cover growing

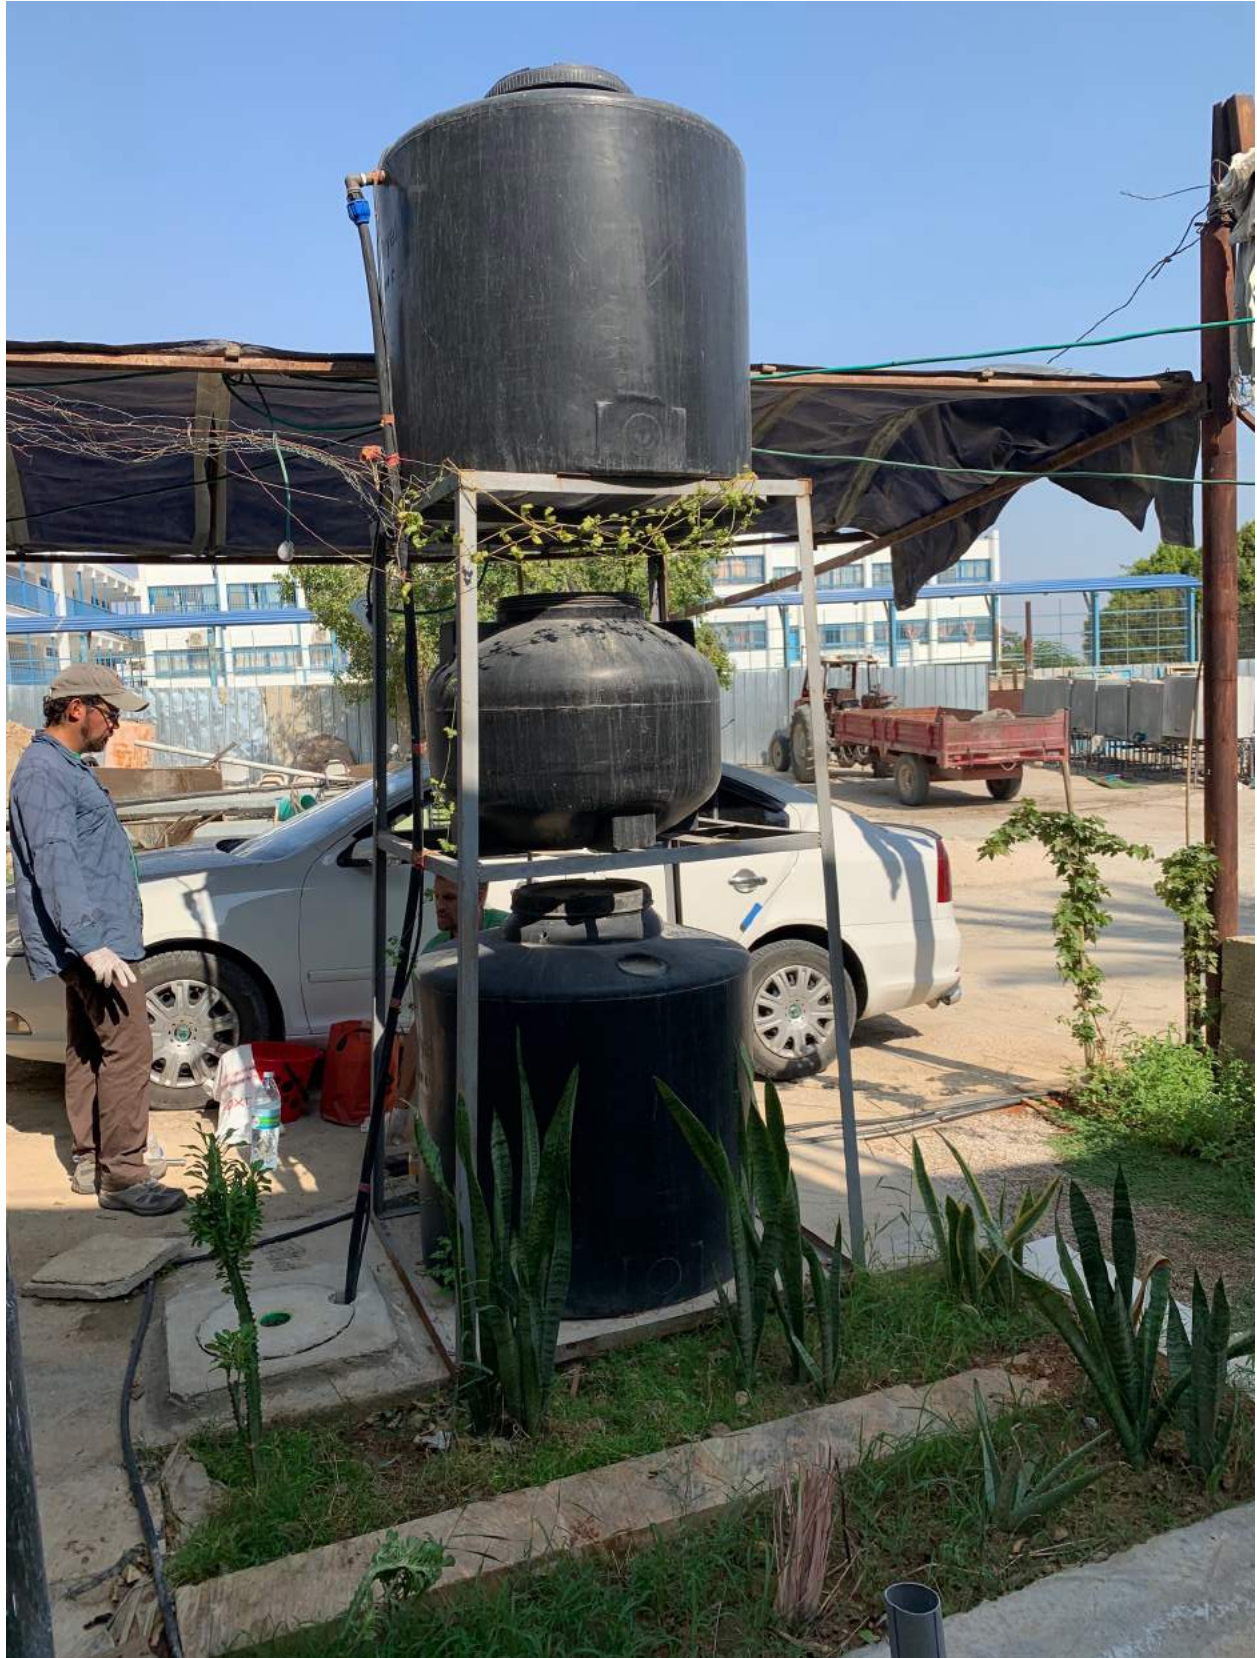
The next place that we visited on October 24, 2019 was Jihad's home also in Al Auja but a much more urban location versus Khalid's. Jihad lives next to a school in Al Auja and has a GWTS for his home greywater and this treated greywater water's 2 palm trees next to his home that are surrounded by a fence. We also sampled here on 2019-09-23.

Photo 8. Jihad's Household Greywater Treatment System on October 24, 2019

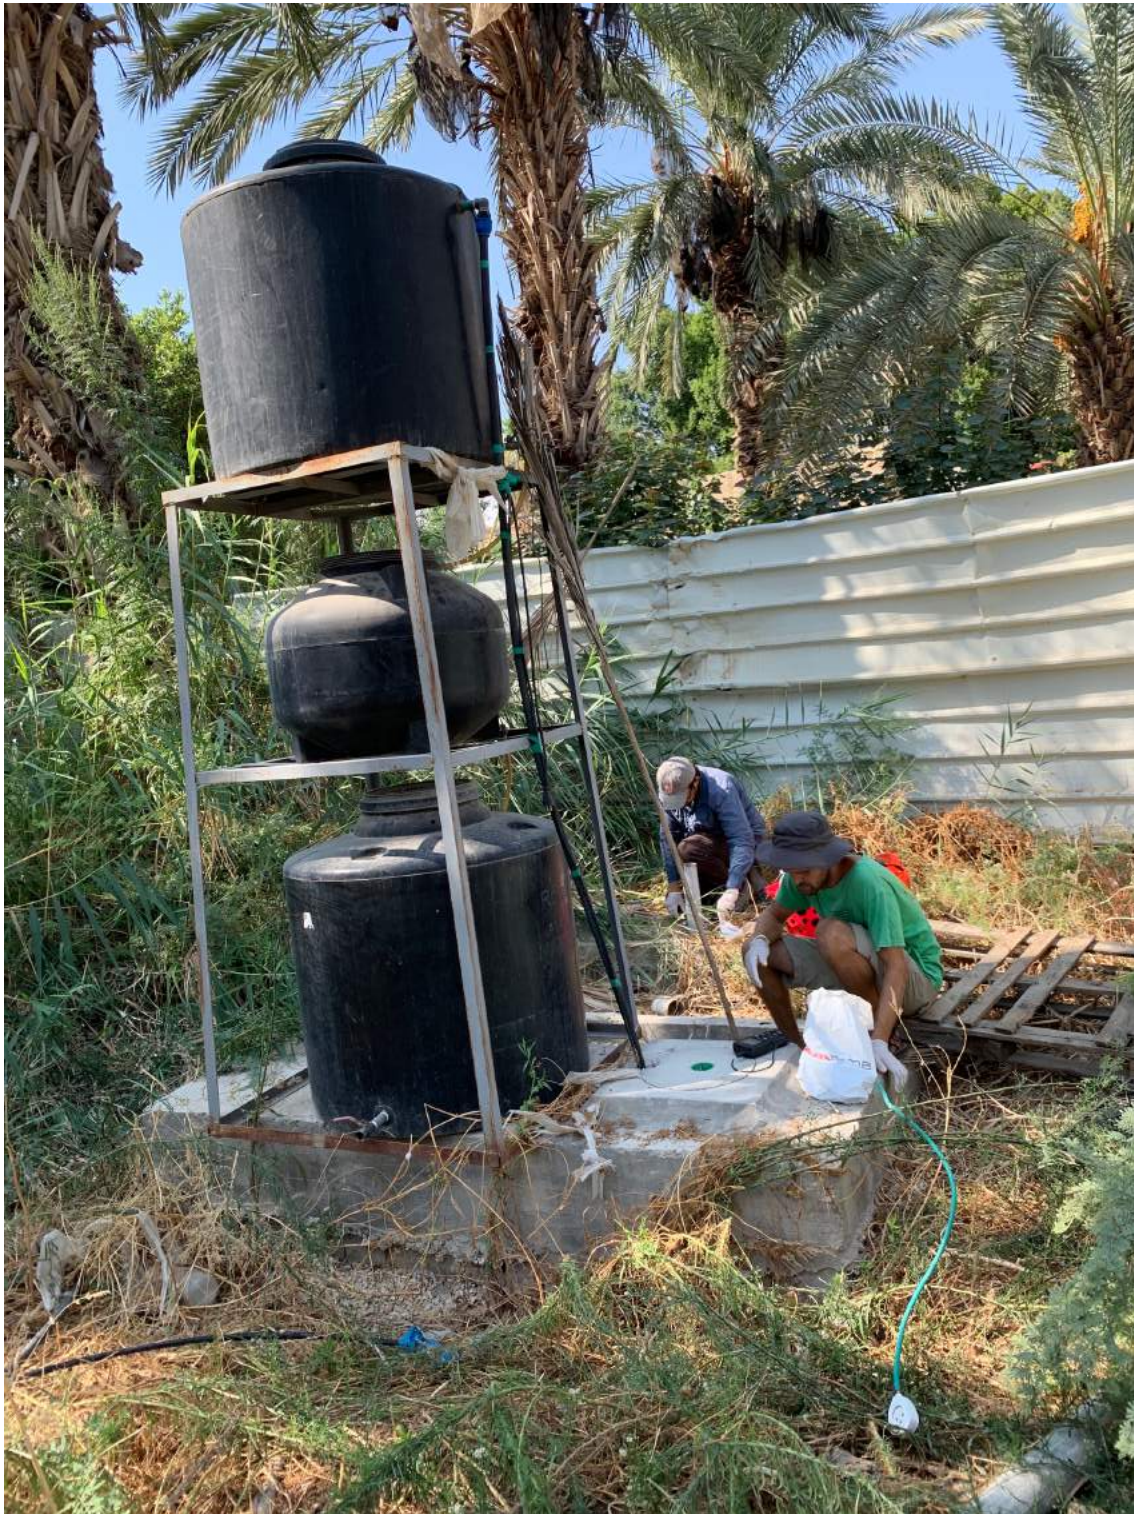
Marj Al Ghazal (town), or Abuljarar Farm as it was called in Report 1, has many systems on site. During this visit on October 24, 2019 three systems were sampled from. This was the second sampling event for all three. The first site that we went to I believe to be the home of Mohamed Abo Jarar Abo Jamal. This system is in the second entrance to Marj Al Ghazal and I have named in my raw data "many houses, second entrance". This system seems to be hooked up and being used by these homes. The treated grey water is stored in the holding tank and released on nearby date palms. In the last report from October 6, 2019 we sampled the influent and the final holding tank. This time on October 24, 2019 there was no water in the holding tank, so we sampled the influent and the effluent underground.

Photo 11. System 1 at Marj Al Ghazal at Mohamed's 4-5 homes. Seems to be working but not hooked up to irrigation at time of sampling as seen in photo

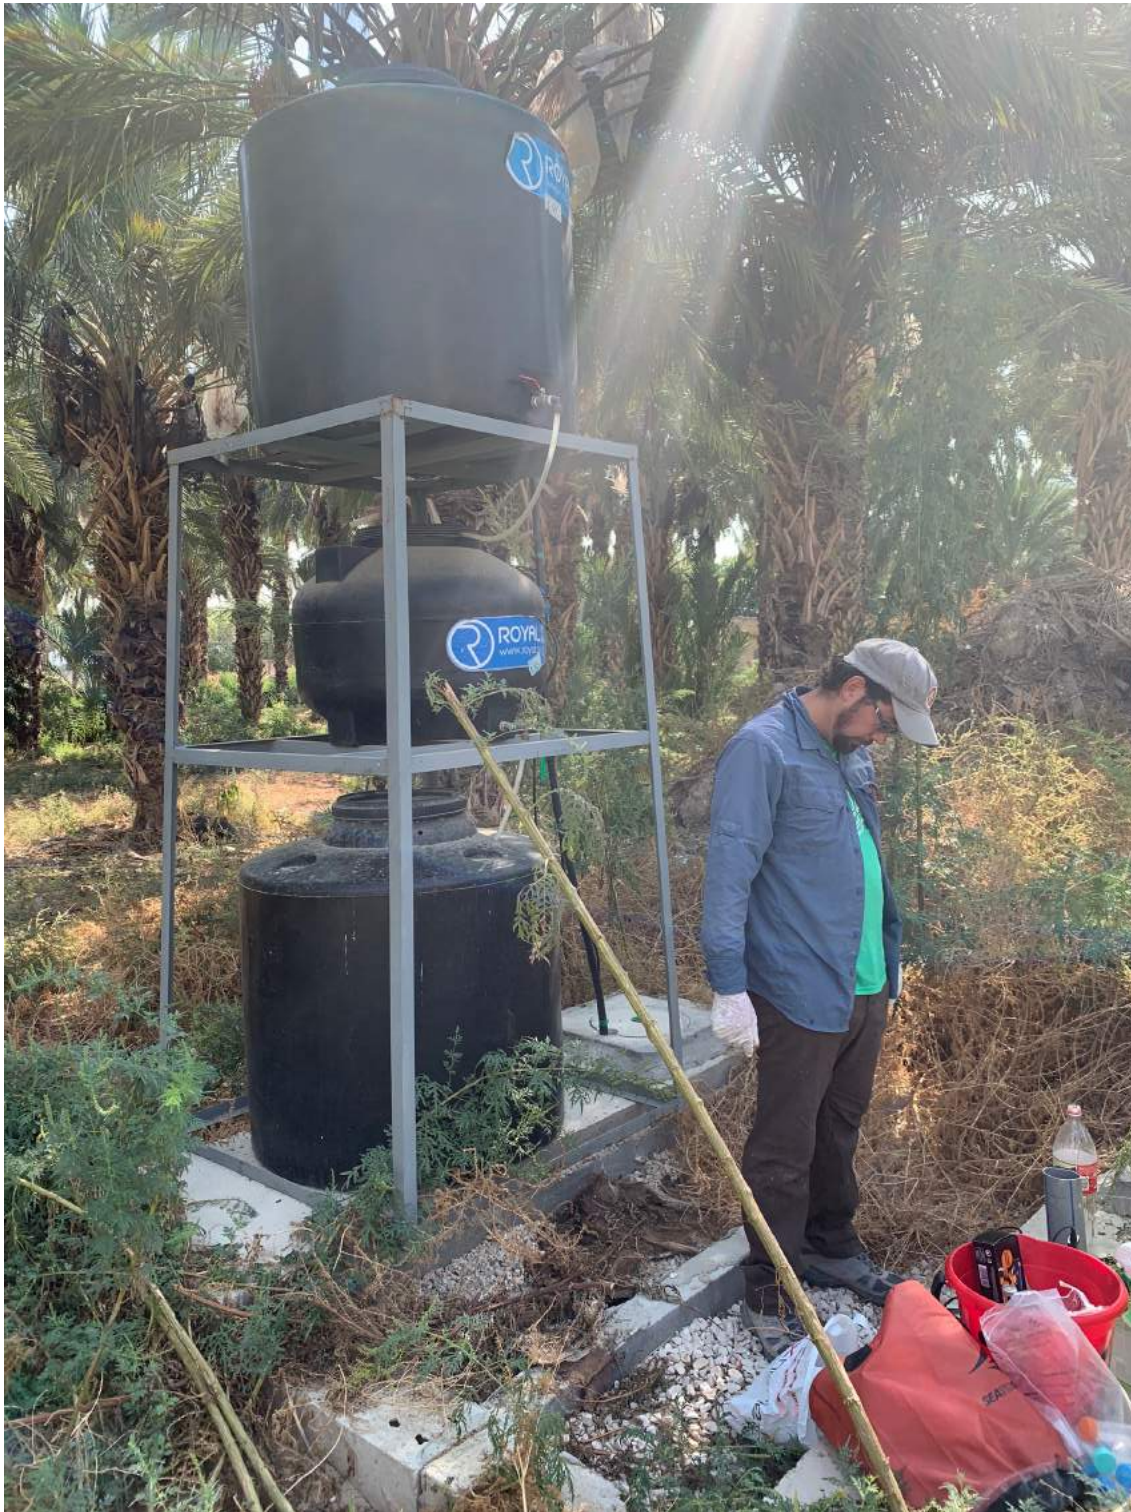
The second location that we visited in Marj Al Ghazal in October 24, 2019 was a system that is more in the center of the community and we believed was hooked up to 3-4 homes and was irrigating 10 date palms. In Report 2, I reported that the Influent from this location was very clear indicating visually that the water was not heavily used by kitchen cooking or showering. The results that I saw from the *E. coli* assessment indicated that the system was not being used much with only 2.6 *E. coli* bacteria in the influent and zero *E. coli* measured in the effluent. This time when we visited Tom looked around the property further and found that the homes were not even piped to the GWTS. This explains why the influent water seemed so clean. After sampling and taking most of our readings is when it was discovered that there were not even pipes from the homes entering the split tank where the grey water is pumped to the GWTS and the blackwater is diverted. Last report we spoke to a member of the community who went on and on about how this system when it overflows, they bring a tractor to divert the water to palm trees and how they manage the system. He must have been speaking generally because this system is not even in operation. This was a perfect example of miscommunication between the translator and the client and also how the translator himself does not even know which systems are hooked up or not or how he does not truly hear the questions the scientists are asking. The samples collected were not processed from this site in the lab because there is no point in processing from a system that is not functioning. There was water in the system possibly for leak detection but not from use as no pipes go to it at this time.

Photo 12. System 2 at Marj Al Ghazal that was found to have no pipes coming in from homes. Did not find out until samples taken and parameters measured upon investigation of area.

Marj Al Ghazal 2 was not tested due to system not being plumbed to homes.

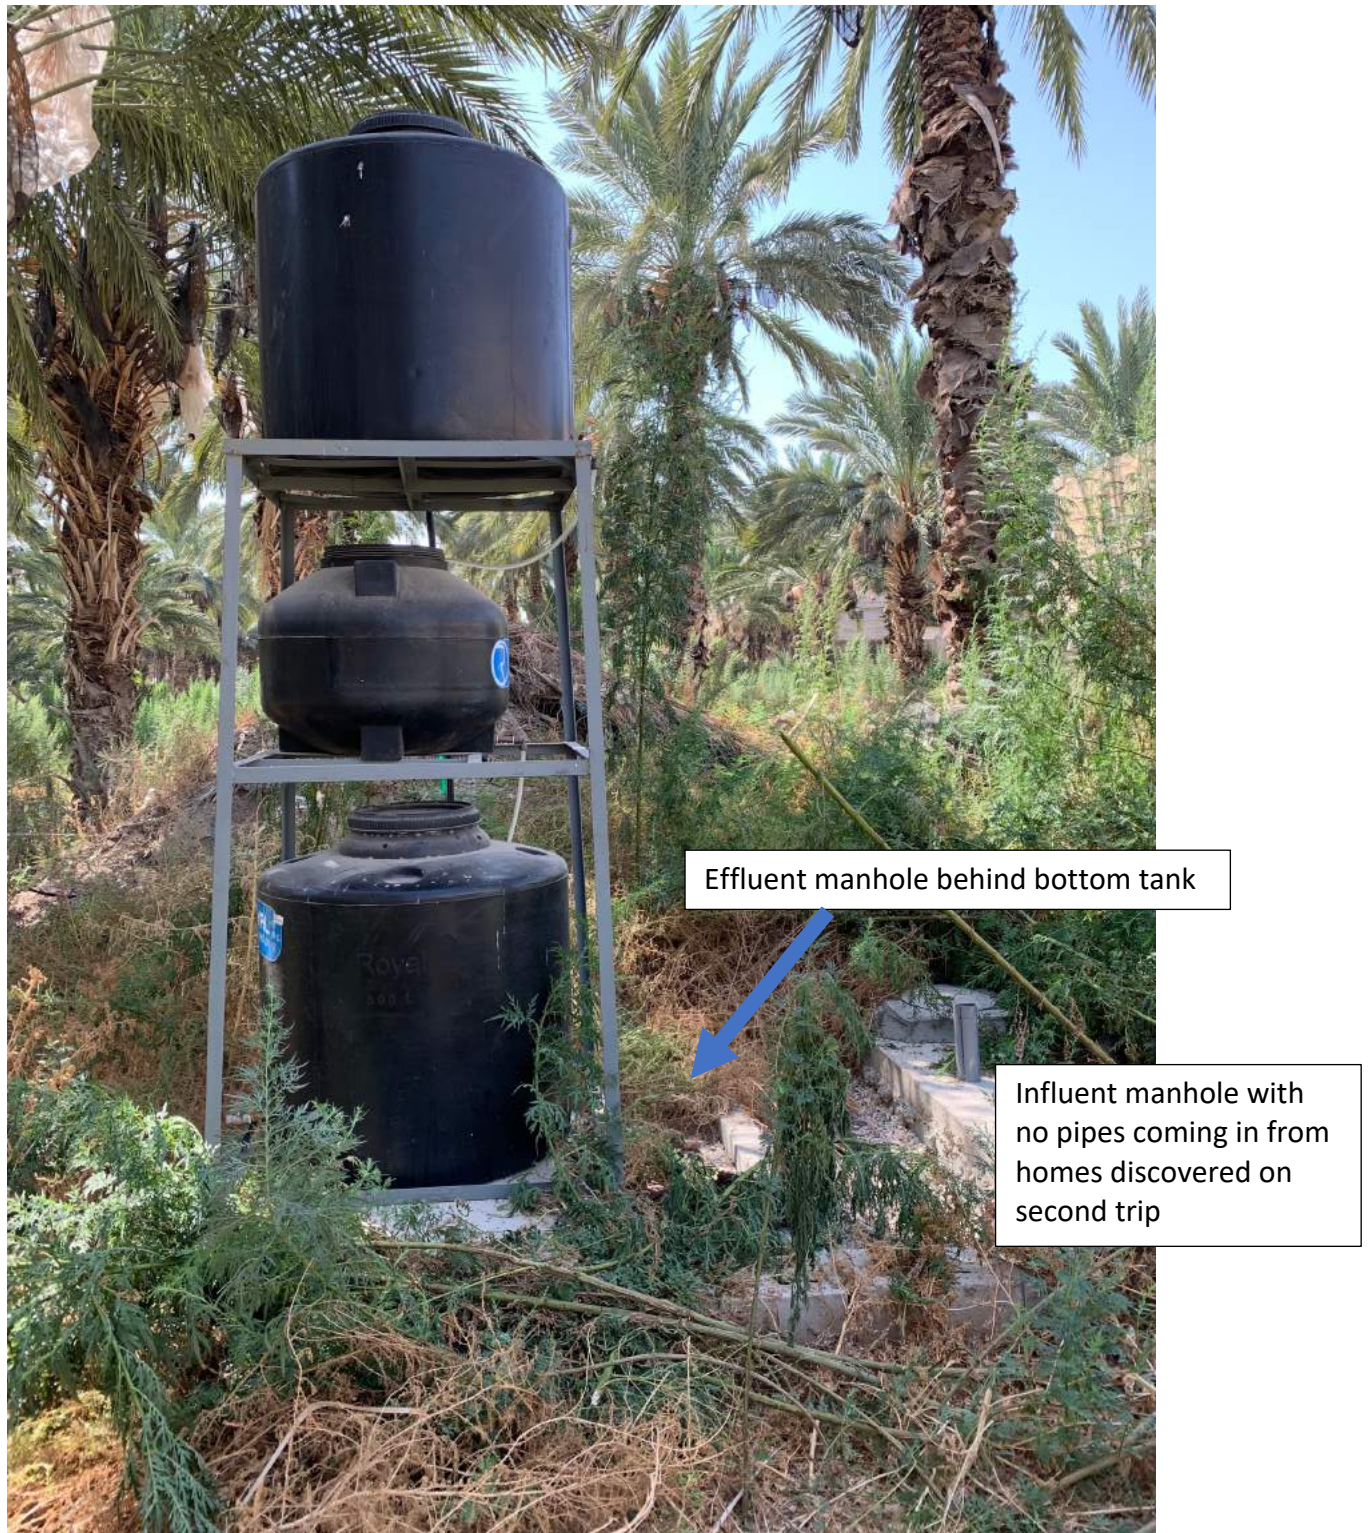
Photo 13. Marj Al Ghazal 2 tank from 2019-10-06 trip when assumed was working—not plumbed and no homes contributing water 2019-10-24

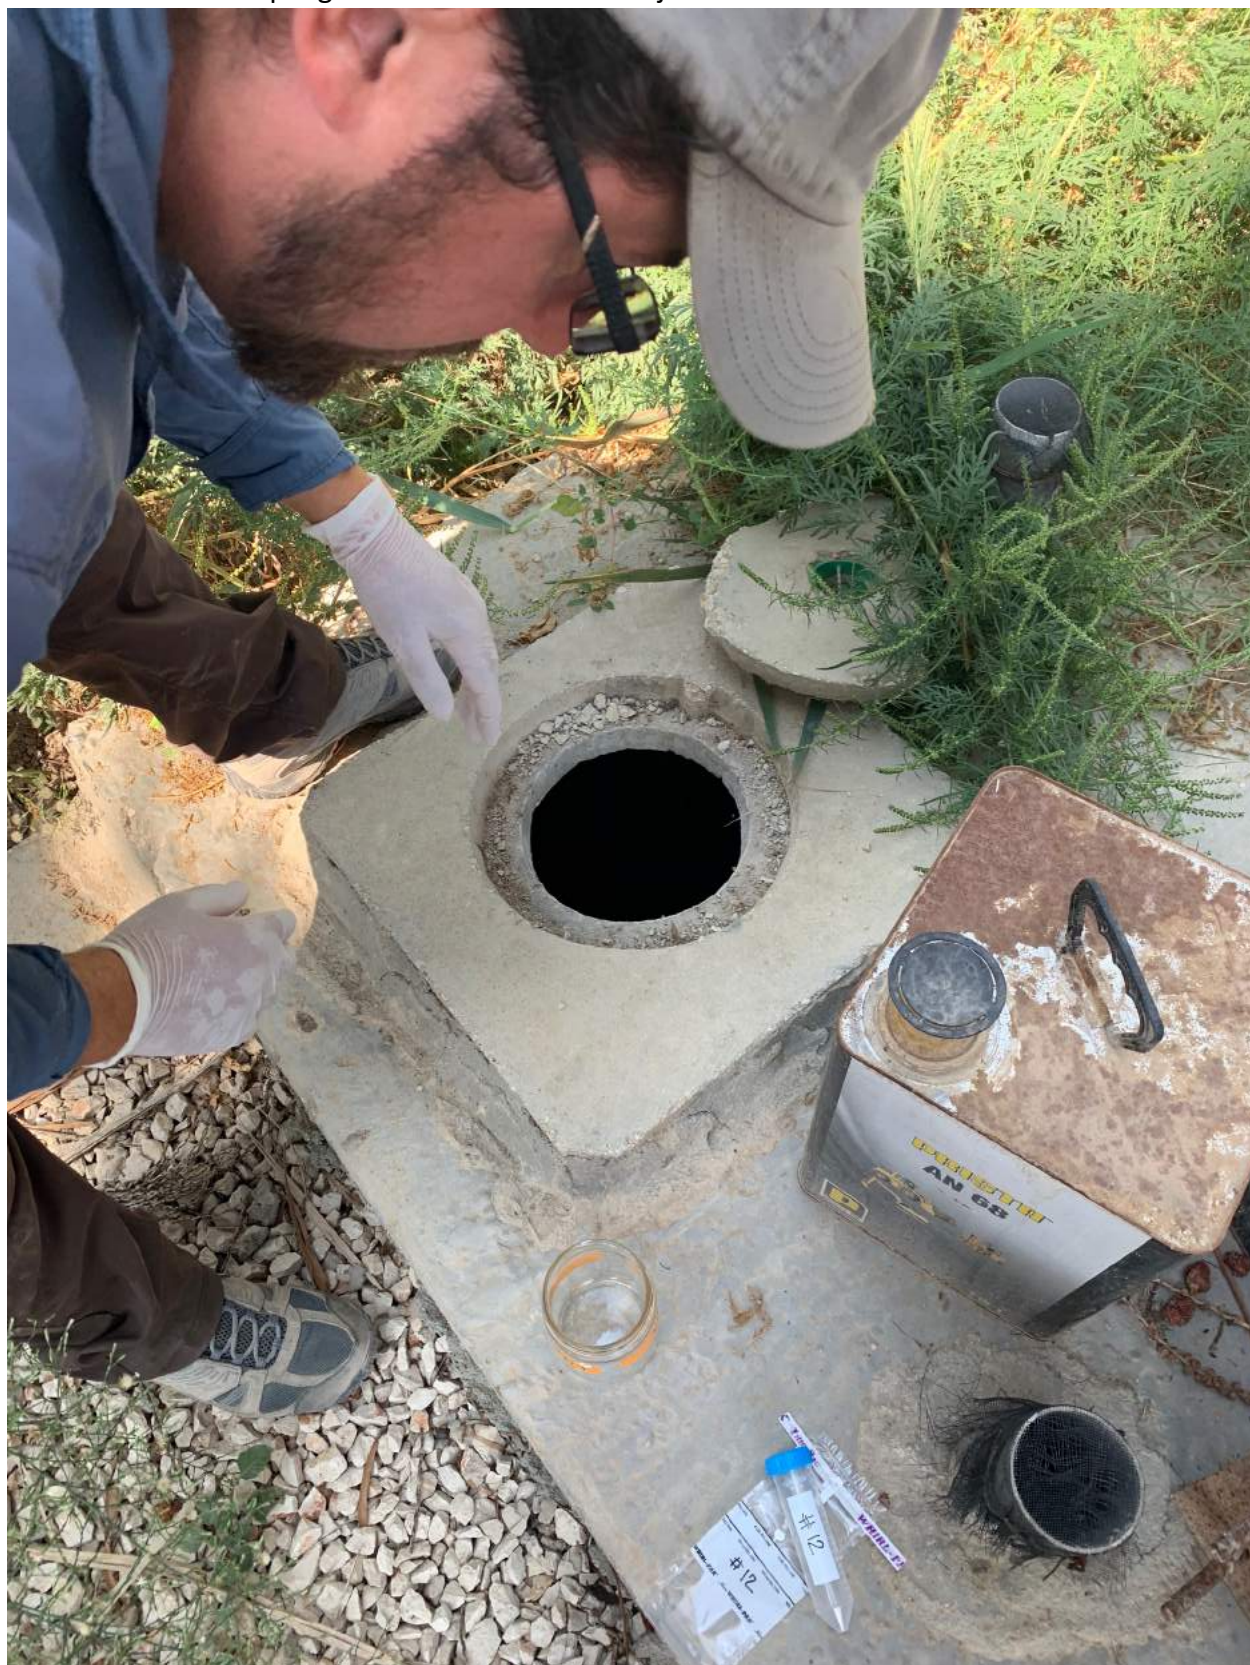
The third system that was visited in Marj al Ghazal in October 24, 2019 we also sampled on September 23, 2019 and at that time was watering a lemon tree so in that raw data sheet that is what is noted in the GPS section. This system, as reported in Report 1, when sampled on September 23, 2019 was using the gravity of the charcoal tower to feed the irrigation to the lemon tree. On that date the influent was sampled and the effluent at the tree was sampled. On October 24, 2019 on the second sampling event the influent was sampled again but this time the system was not irrigating any trees. The effluent was sampled from underground because the holding tank was emptied. On both occasions the influent was sampled and the effluent without the use of the charcoal filter was sampled. Based on the results of the influent during this sample event I think that this system may not be hooked up to homes as well. The influent had little *E. coli* numbers and the effluent had high numbers. We assessed the area and it seemed like this system was not directly hooked up to homes at the time but the whole area had been covered in a thick layer of dirt and it was hard to follow any pipelines. Communication about system use is critical to project purpose, effectiveness and longevity of research.

Photo 14. Davis sampling influent manhole at Marj Al Ghazal 3 "lemon tree"
