Summary of Water Quality Assessment Findings
Greywater Sampling Report 3
Auja and Marj al Ghazal
Sample Date: 2019-10-24
Written By: Natalie Brassill

On October 24, 2019 a team of scientists from the Arava Institute traveled to the West Bank to Auja and Marj al Ghazal, for the third time, to assess Grey Water Treatment Systems that have been installed on site at homes in the area to treat household greywater using a similar design to the Septic Tank Up Flow Gravel Treatment unit as shown below in Figure 2.1. (Greywater Use in the Middle East: Technical, Social, Economic and Policy Issues, Monther Hind design) This design was modified by Monther Hind to fit the needs of each on site location.

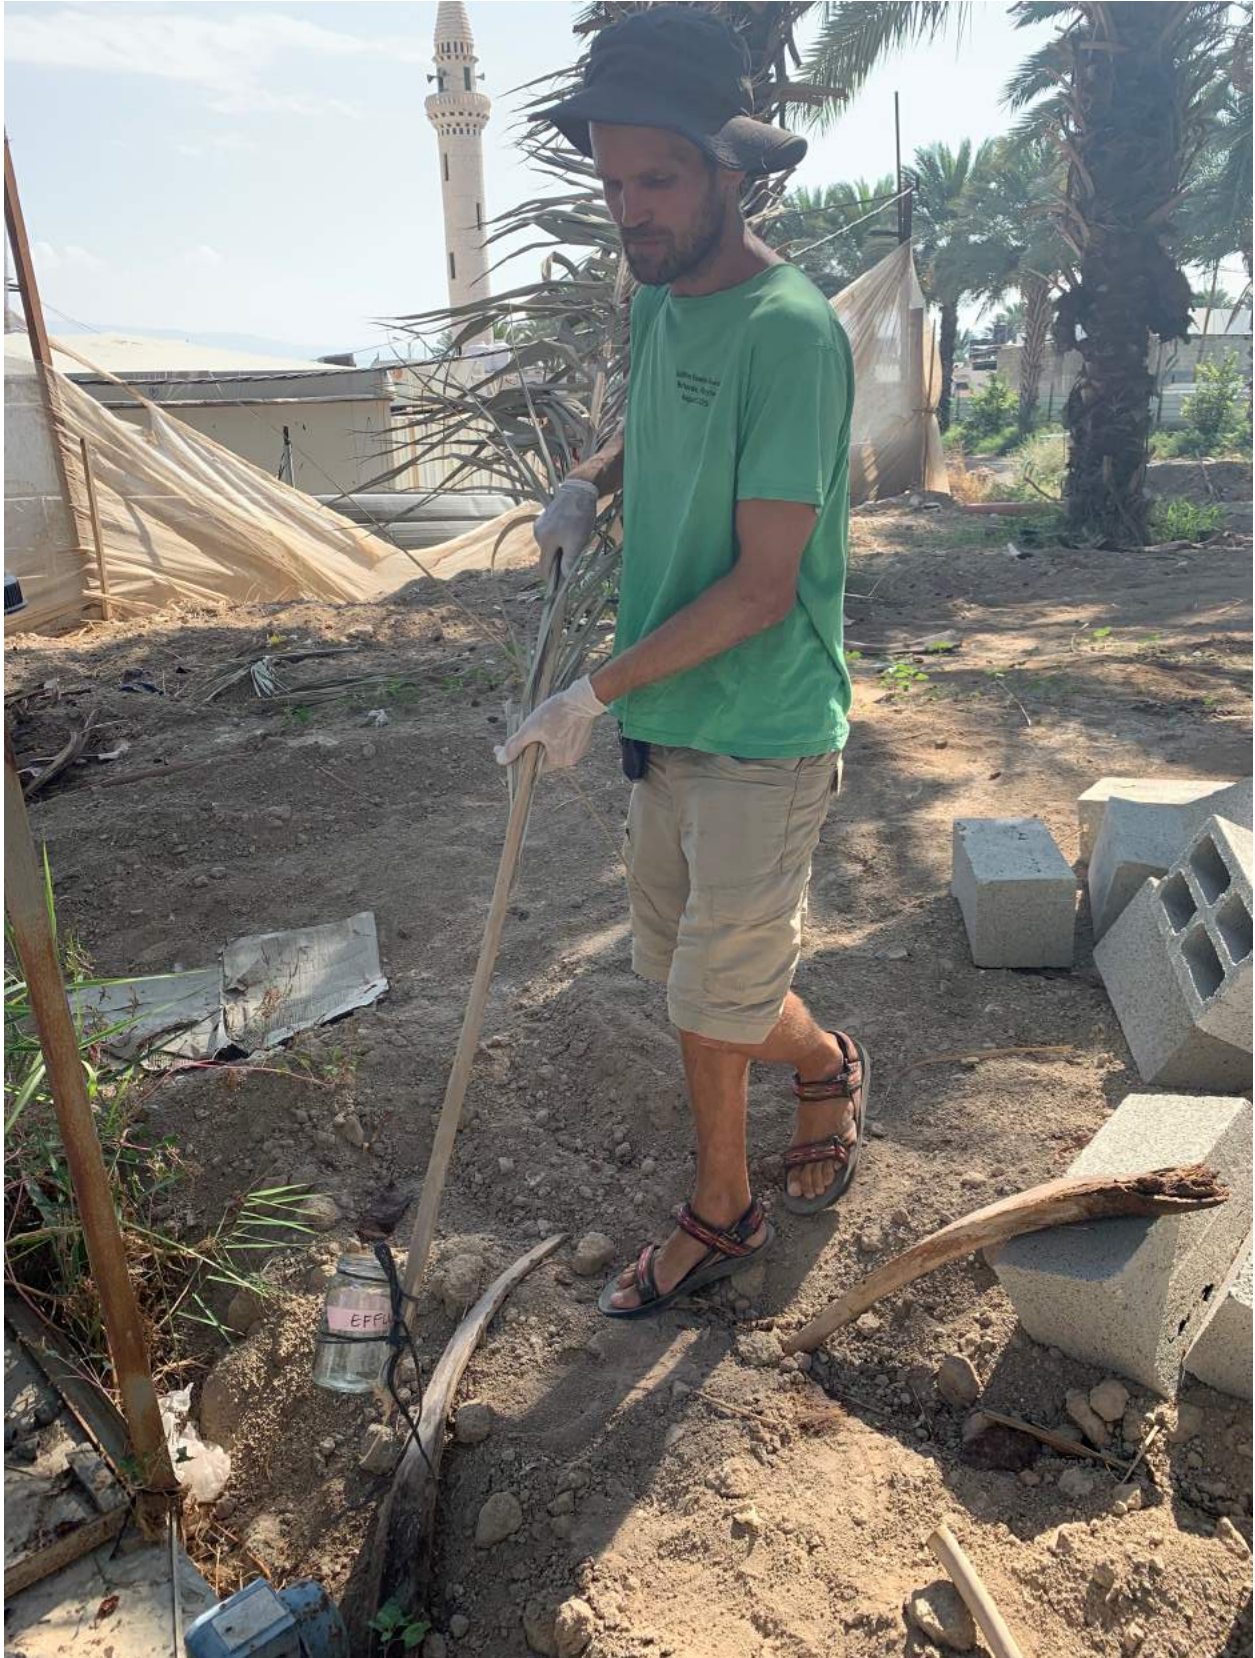
Photo 16. Tom collecting effluent sample. See debris around indicating construction

Marj Al Ghazal 3 was tested. This is the site at the "lemon tree". This site appeared to be under construction or tampered with and that is what results seemed to indicate. Marj Al Ghazal 3 was sampled both from the underground influent and effluent as there was no water in the holding tank or irrigating. An increase in pH was recorded from 7.95-9.04, a decrease in EC from 394 ppm-287 ppm, an increase in DO from 1.39 ppm-6.25 ppm and a decrease in turbidity 89 NTU-23.26 NTU. It is interesting to see an increase in DO in the underground treatment that is supposed to be anaerobic, this may indicate a lack of use or an oxygen leak of some kind. The fecal indicator bacteria *E. coli* also showed an odd result of an increase post treatment indicating treatment ineffectiveness. *E. coli* readings were 13.6 MPN/100mL in the influent and increased to 1200 MPN/100mL in the effluent. This may indicate that there is harboring bacteria in the underground up flow gravel treatment system or that the system is just not running optimally. This needs to be further investigated to see if the homes are actually hooked up and pumping water to the system as well as determining how the system has been maintained. In Report 1 when this system was last tested there was 1.5 MPN/100ML in the influent and zero bacteria in the effluent indicating little use of the system then. A follow up interview is required to know more.

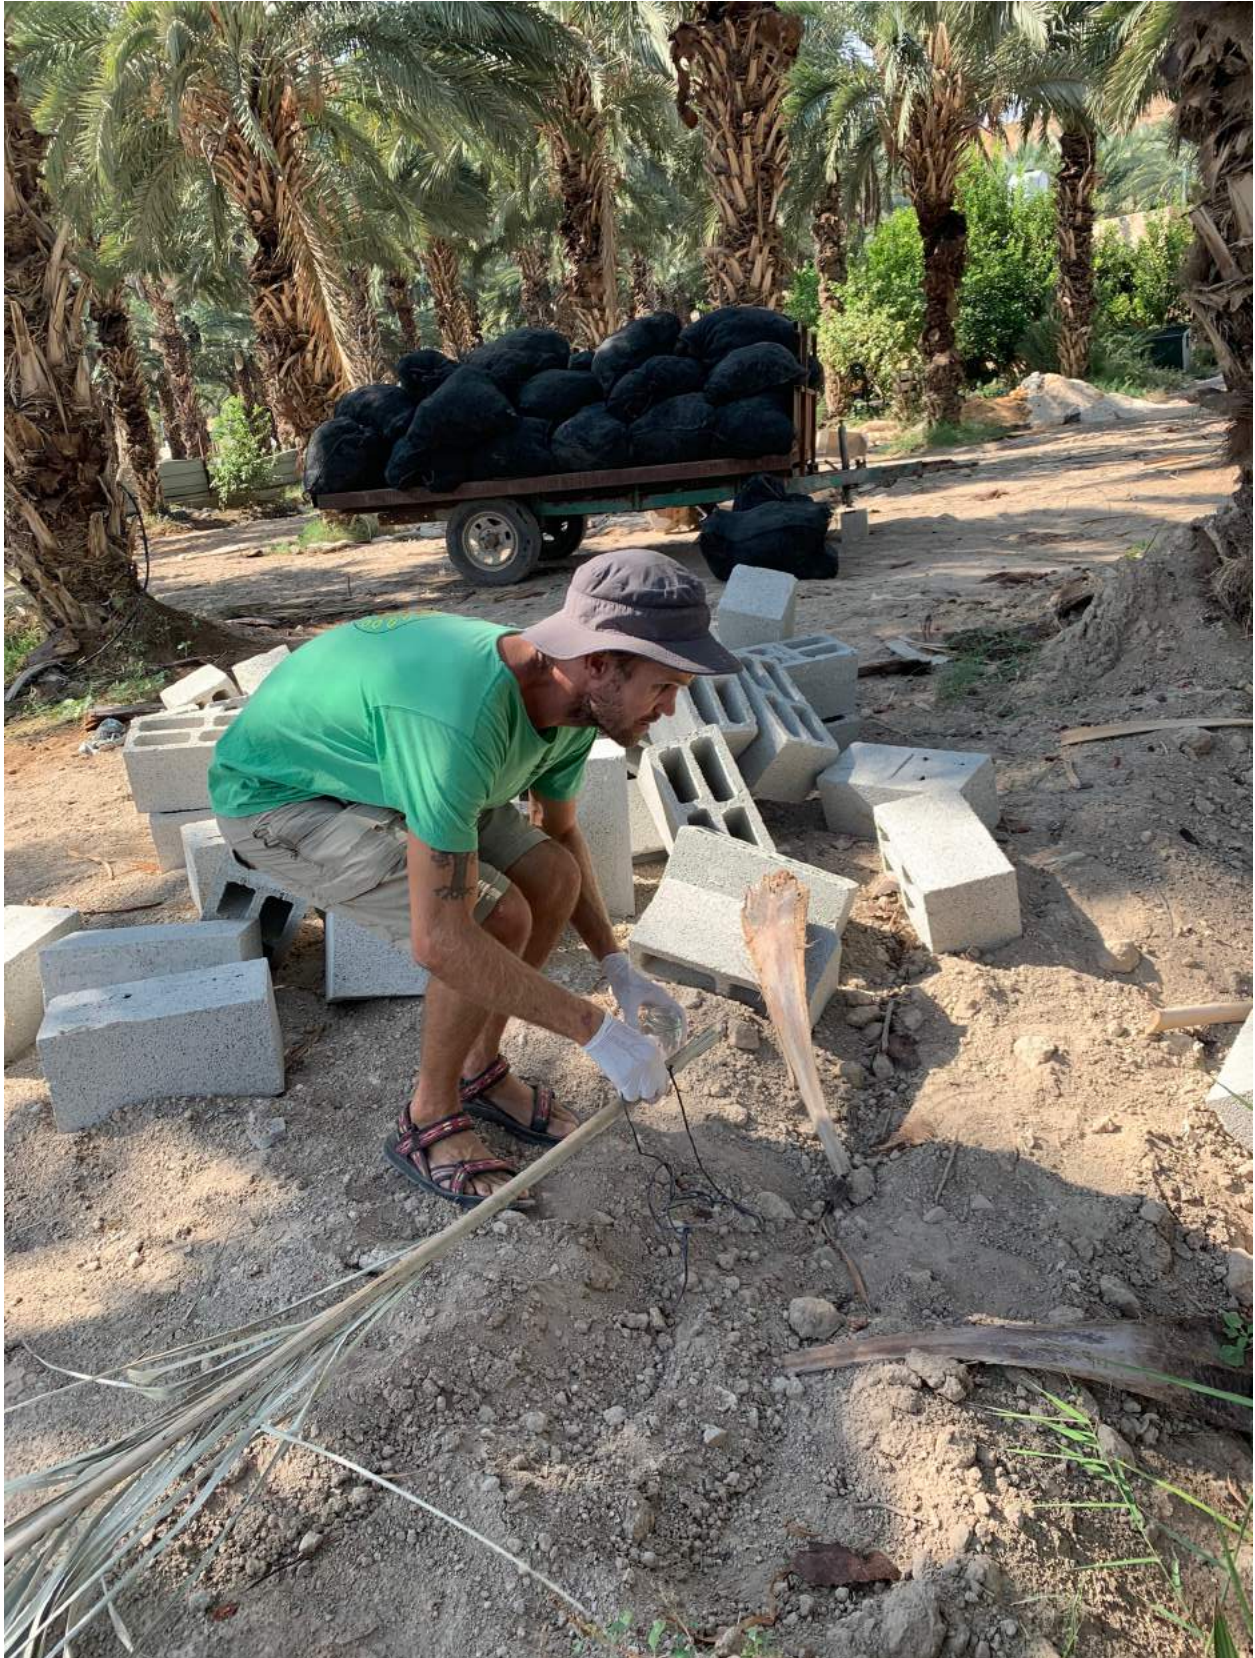
Photo 17. Another angle of Marj Al Ghazal 3 “lemon tree” dirt cover and cement blocks

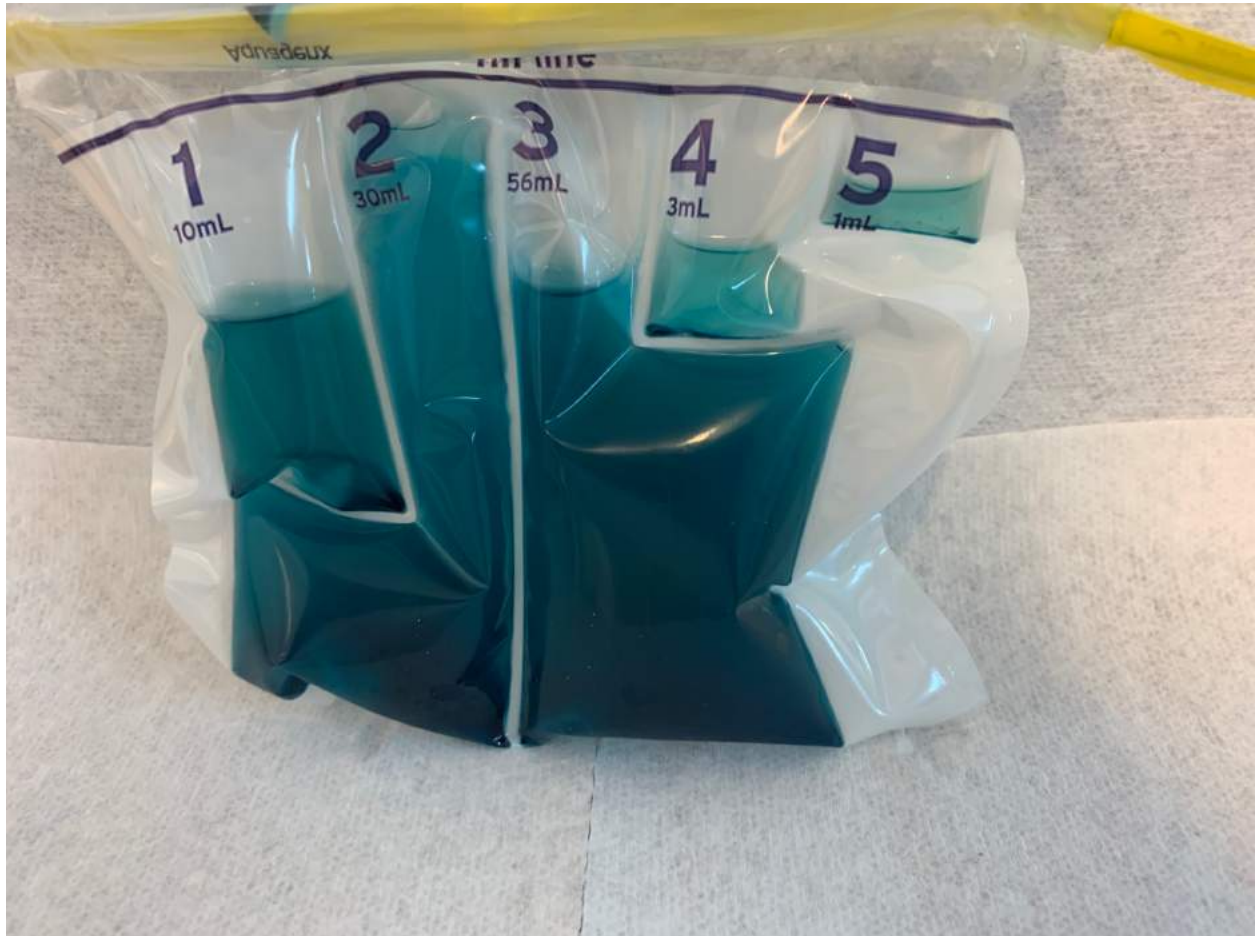
Photo 33. Compartment Bag Test post incubation with *E. coli* >100 MPN (blue color change)
